Inspection Report
Minerals Regulatory Program
Report Date October 21, 2005

Mine Name: Duke
Operator Name: Ridgepoint Mining

Permit number: S/037/096
Inspection Date: September 14, 2005
Time: 8:30-9:15 AM

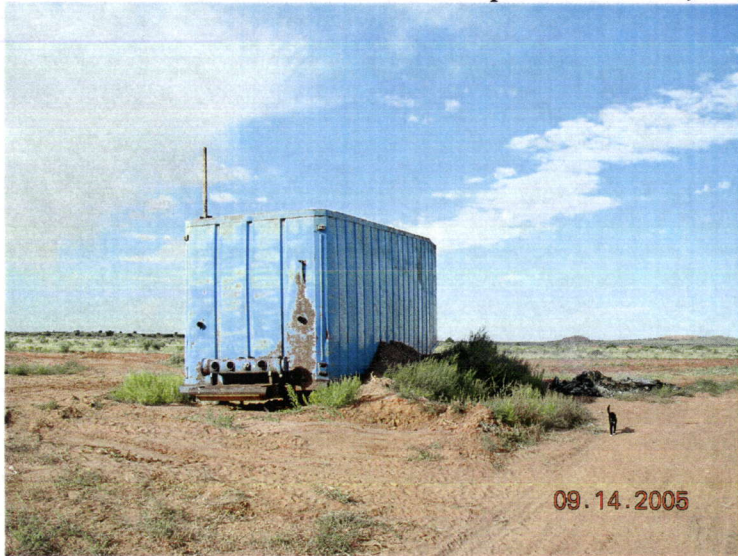
There is a frac tank on site (Photo 1), and if the site is reclaimed to an agricultural use, this tank might be used for storing irrigation water. This would need to be approved by SITLA.

Photo 1. The frac tank.

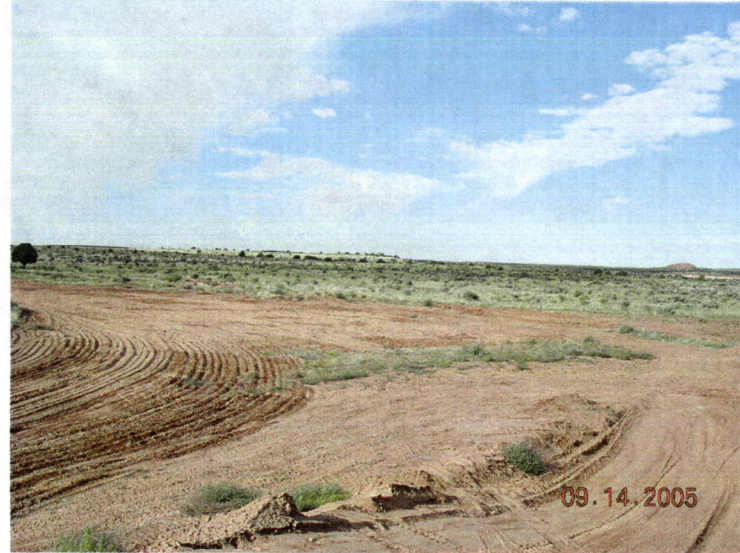
The area is being used essentially as a racetrack or an ATV park, apparently by people living in the adjacent community. The operator created several windrows and piles of sand which make the site more attractive than adjacent flat areas (Photos 3 and 4). While nothing the operator has done is extraordinarily hazardous—there are no highwalls or cuts—the operator may have some liability if someone was to be injured.

Photo 3. A corner of the mine site being used as a racetrack.

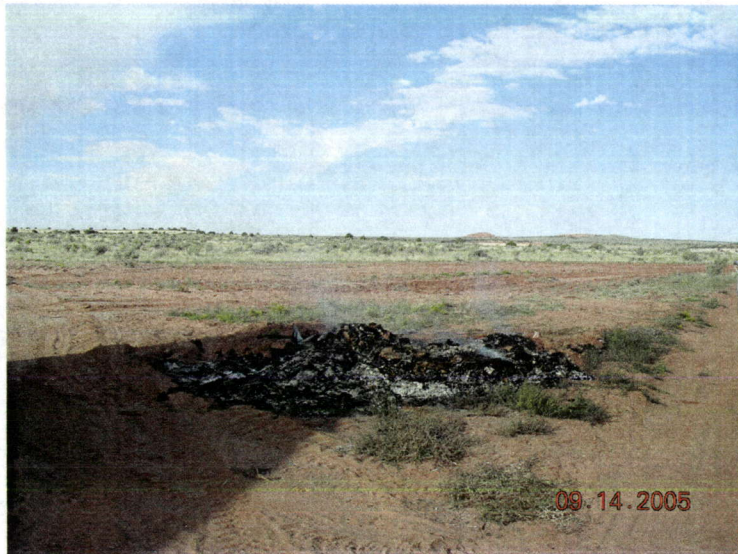
Next to the mine site, there is an area used for disposing of garbage and/or storing scrap. It appears the community residents also burn some of their trash on the mine site (Photo 2).

Photo 2. There was some smoldering trash on the mine site.

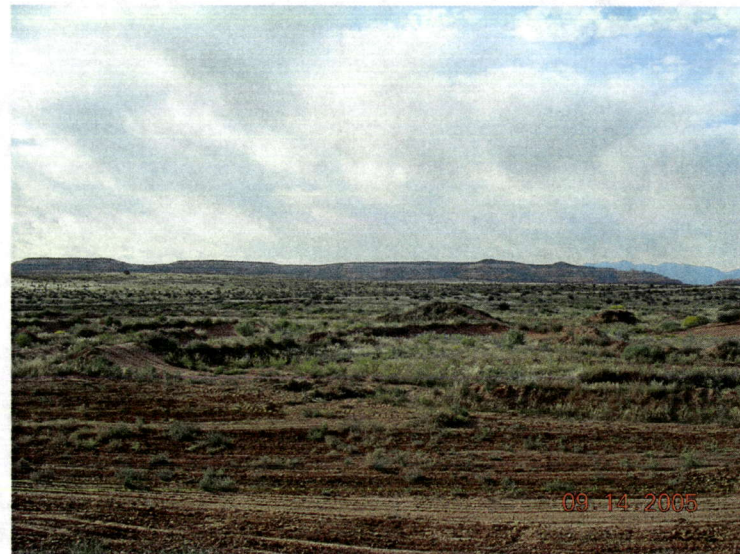
Photo 4. The piles of sand the operator made add interest for ATV riders.

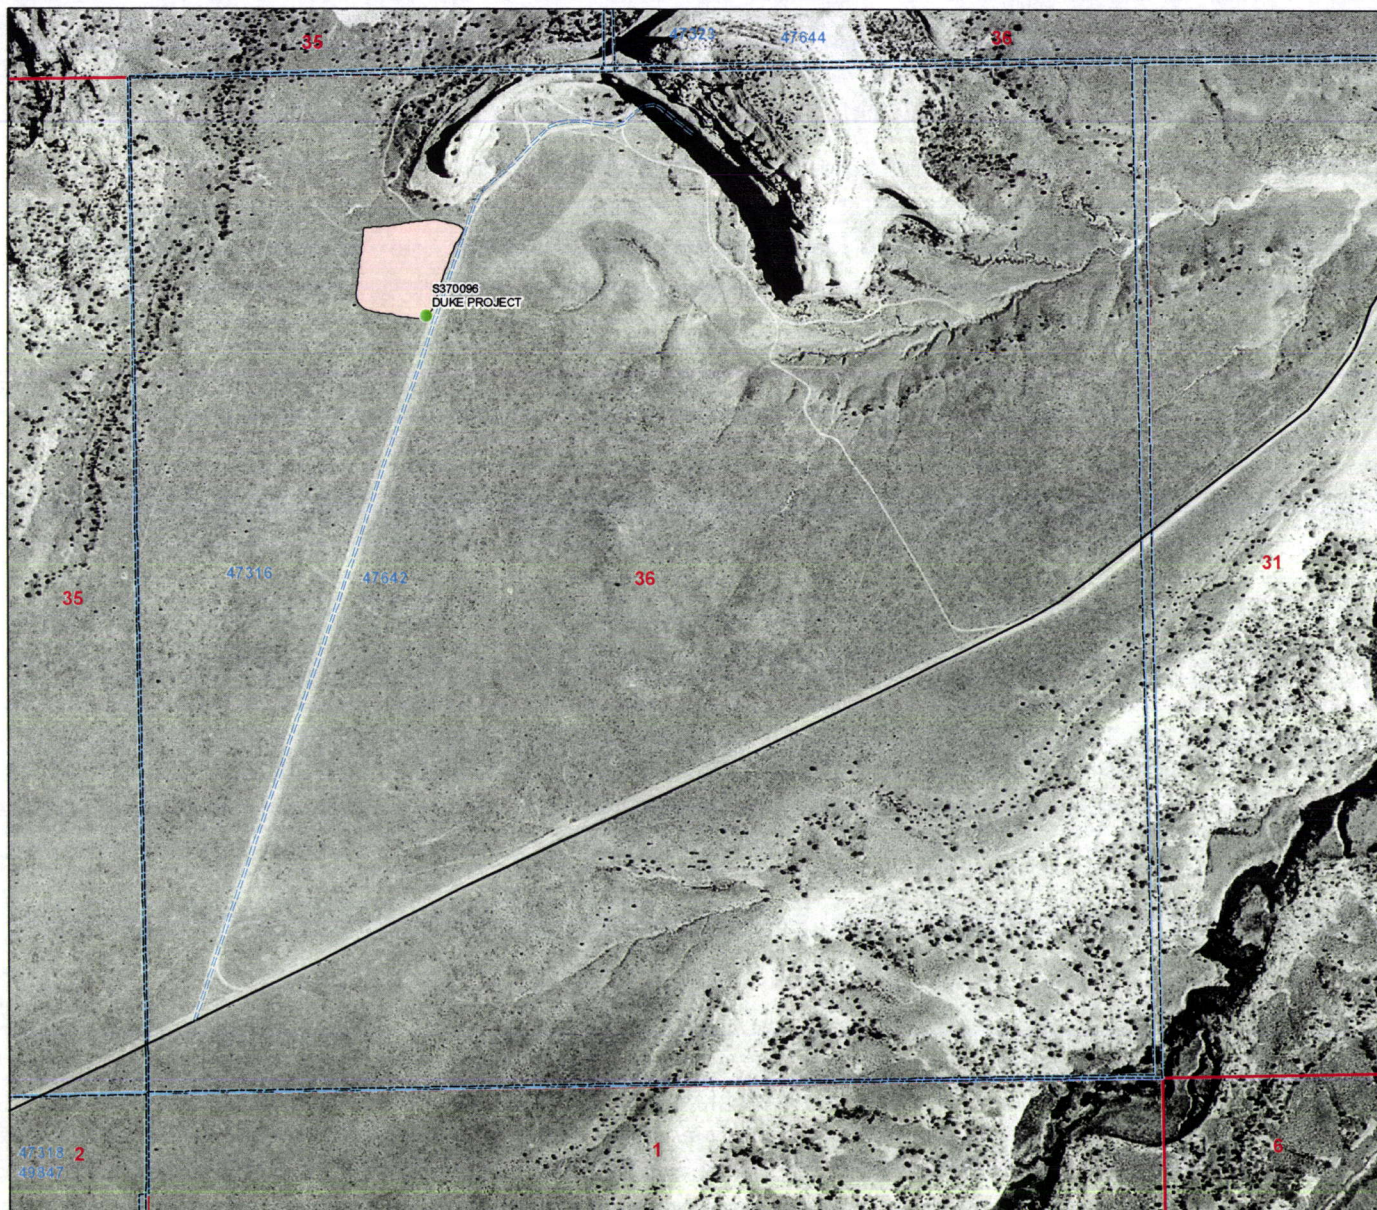
Mine Number: M0370096
Mine Name: Duke Project
Township 29.5 S Range 22 E Section 36 SLBM

I used a GPS unit to create a map of the disturbed area, and a copy of the map is attached to this report. The site is just under five acres.

Acres Disturbed	4.87
Acres Regraded	0
Acres Seeded	0
Road Acres Disturbed	0
